# **WP 10 Deliverable No. 10.5 – D65**

## **Report on the characterisation of MPOs**

Project acronym:  
**AHEAD2020**

Project Title:  
**Integrated Activities for the High Energy Astrophysics Domain**

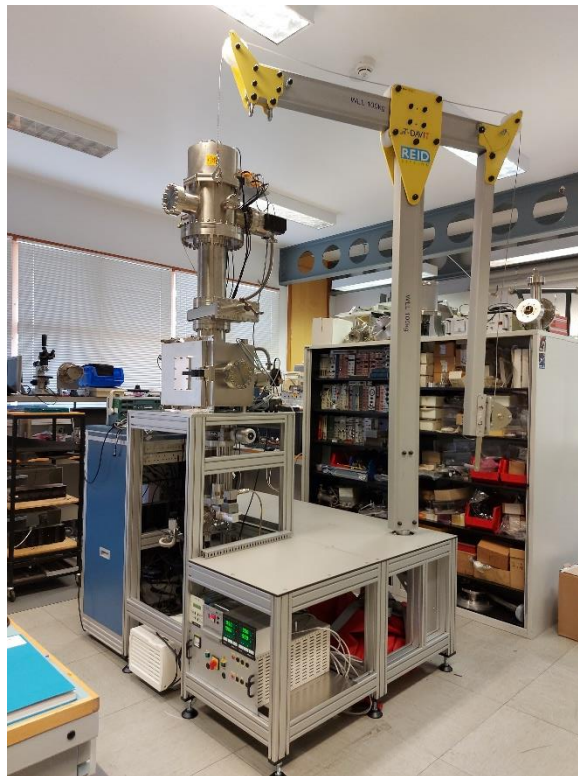
The purpose of the VTF (Figure 1) is to enable fast screening of individual MPOs and provide fast screening of large batches of optics. In order to determine how long it would actually take to change over from one MPO under test to another, several dry runs of the procedure were performed. The current estimate, based on these dry runs, is 2 hrs, far quicker than originally thought. This would enable up to 3 MPOs and possibly 4 to be tested in a day.

*Figure 1: The VTF facility.*

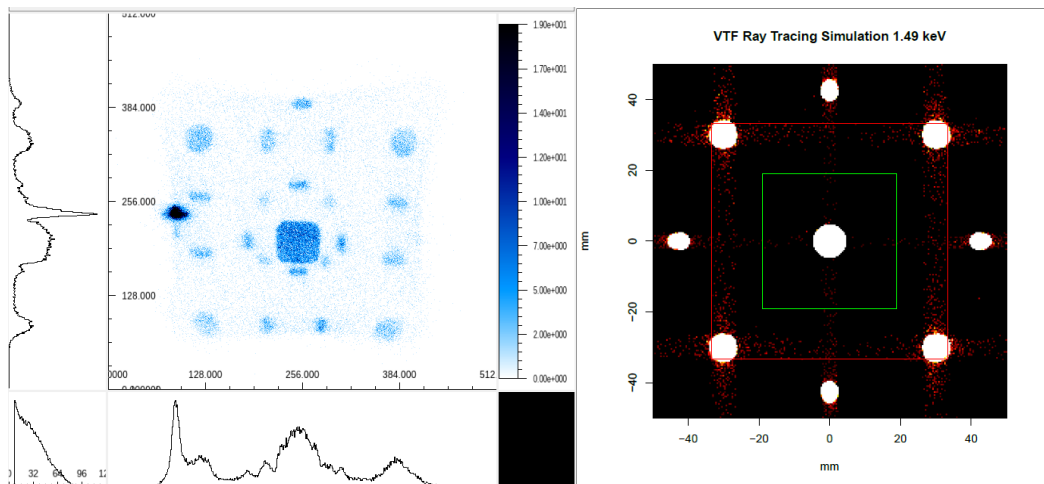
The first MPO was placed in to the VTF test facility and an image obtained (see Figure 2). This image was not as expected and highlighted the need to improve the modelling. Work has been undertaken to improve the model and is still ongoing.

Figure 2: First image of an MPO using the VTF on the left and a model of the set-up on the right.

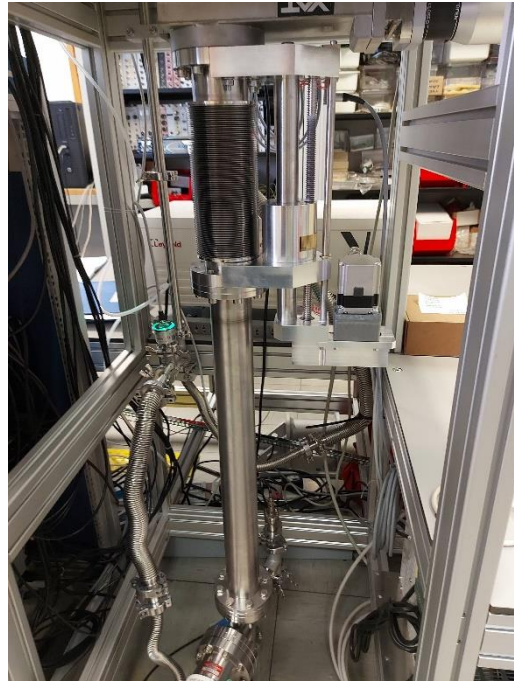
Figure 4: Extension added to the source section to try to make the source to optic distance equal to the optic to detector distance.

The first THESEUS MPO was placed in to the facility and an image taken as shown in. This image showed that for a flat MPO, as is the case for the THESEUS MPOs currently, the source to optic distance and optic to detector distance have to be exactly equal in order to measure the MPO. The facility was adapted (Figure 4) to get the distances as close as possible and a series of images were taken during alignment of the MPO (Figure 5).

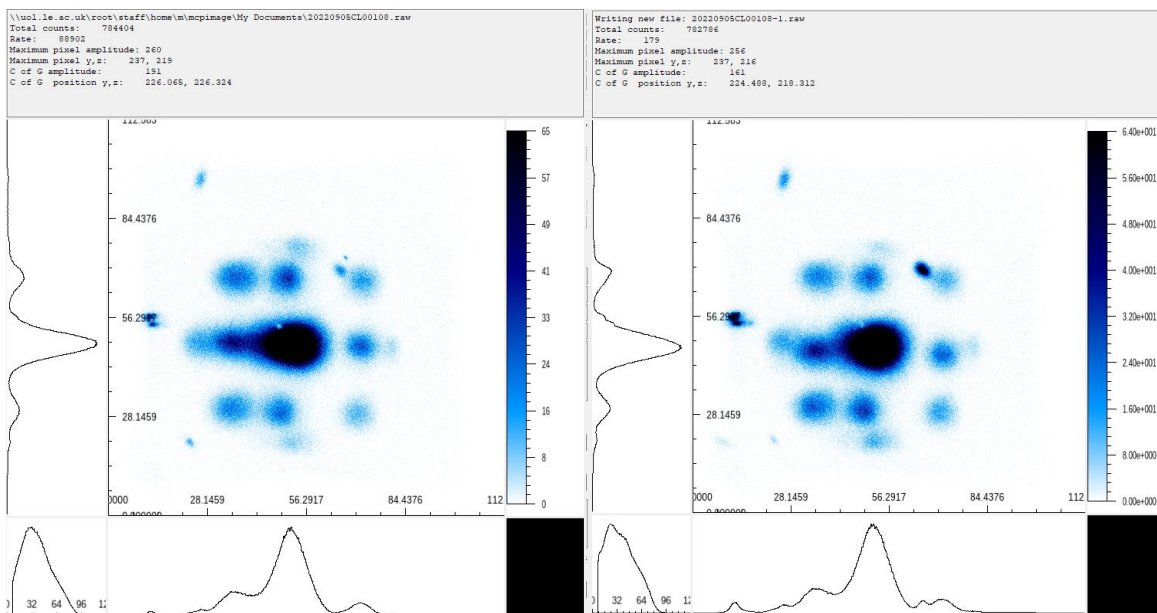
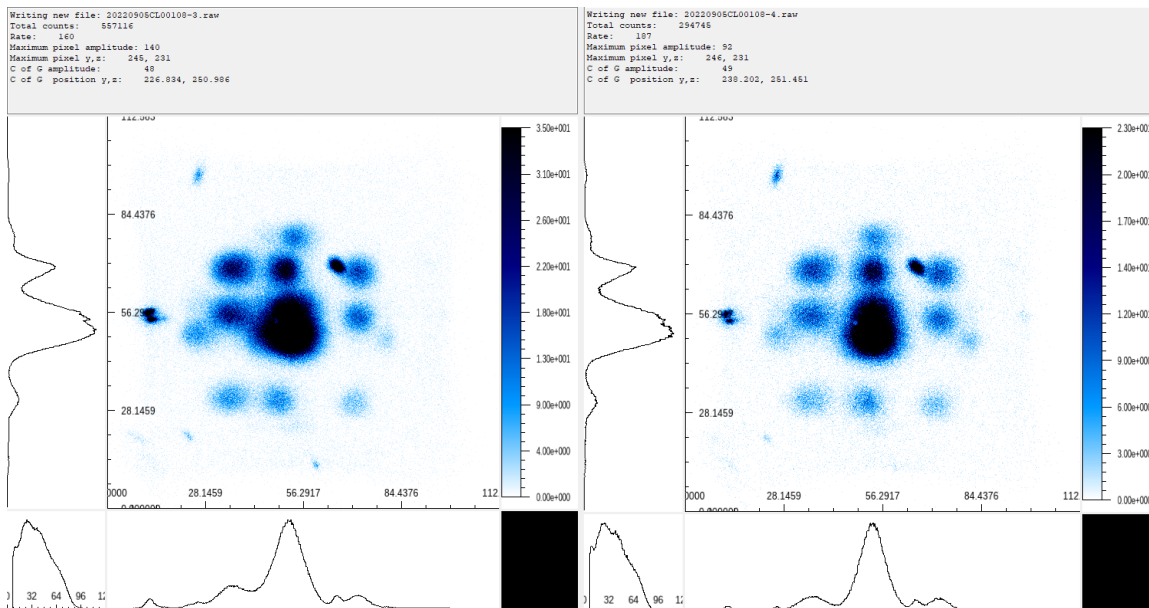
Figure 5: Series of images taken of the first THESEUS MPO during alignment.

Unfortunately, during this series of images, the electronics that control the X-ray source suffered a high voltage break down due to age (20 years old) and had to be returned to the manufacturers for repair. During this period, additional pieces of hardware have been purchased to allow greater control and flexibility of the source to optic and optic to detector distances. In addition, the mounting and optic manipulation stage are being upgraded to improve the movement of the optic and to stop the manipulation stage from jamming during optic alignment.
